## 5.3 Full-scale Fire Protocols

## 6 Test Results

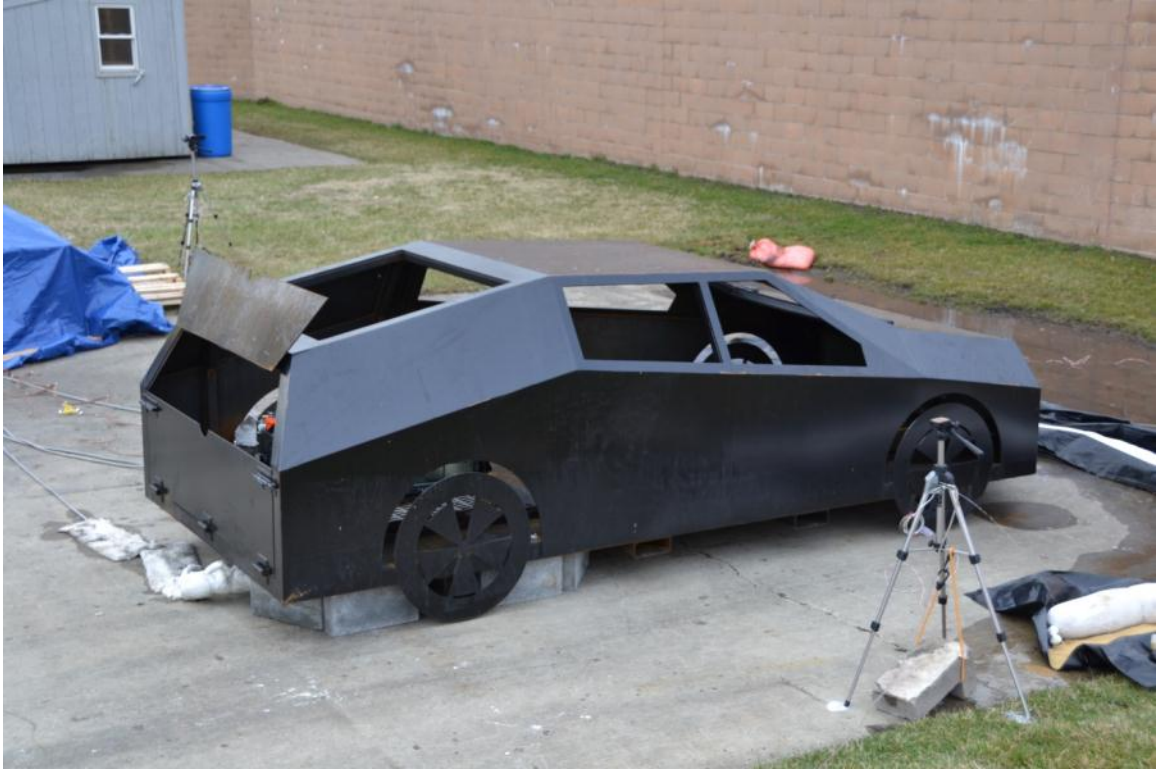
Figure 49 VFT windows were all open to air and the top portion of the back hatch was kept open to during the tests

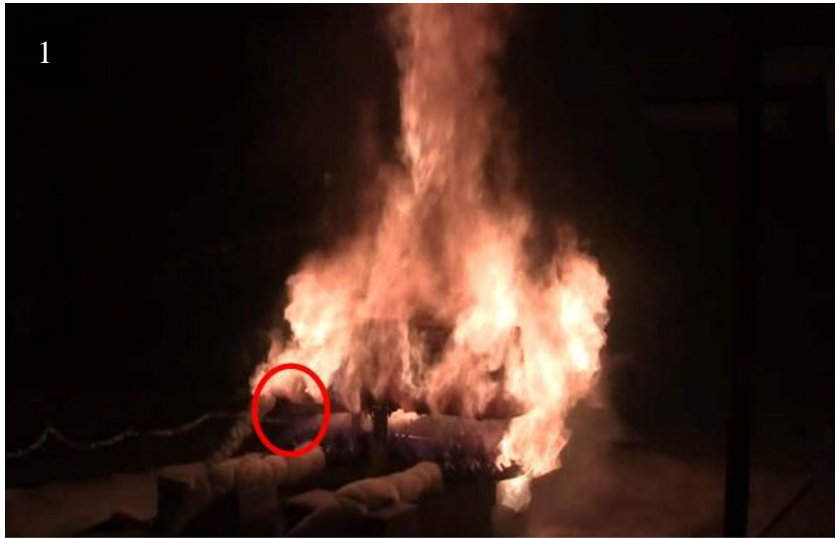
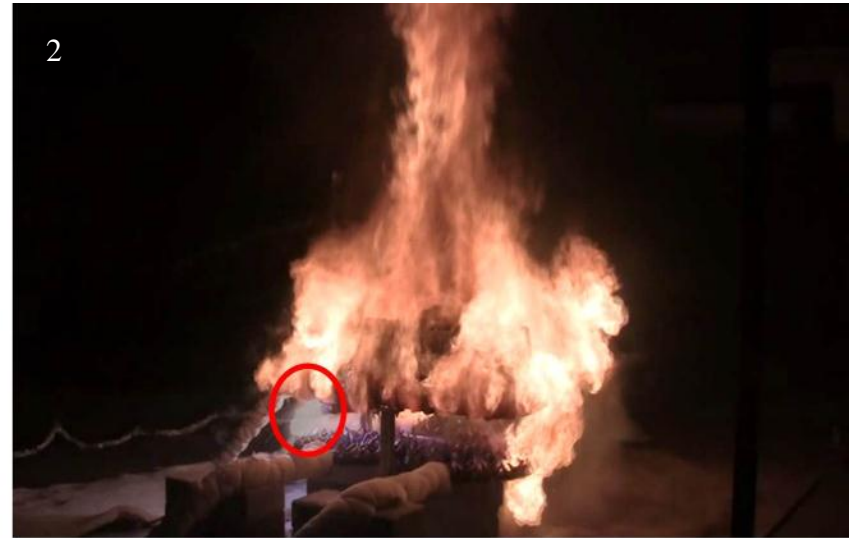
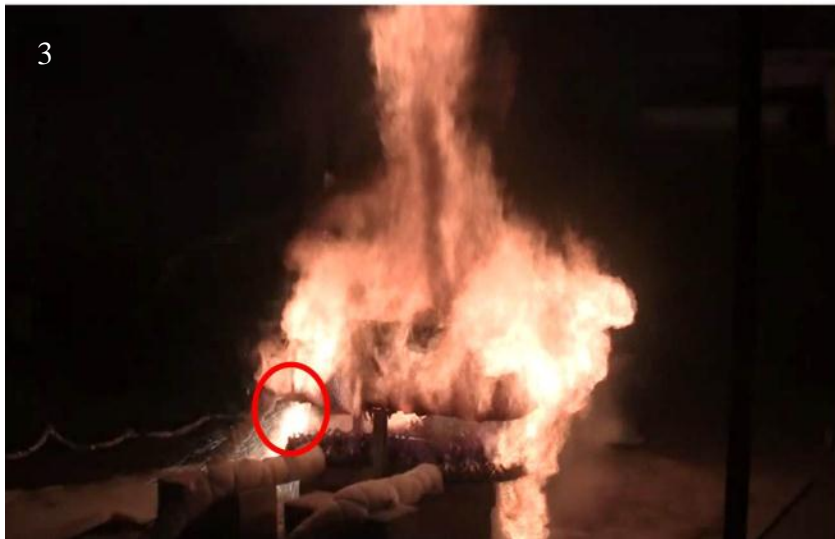
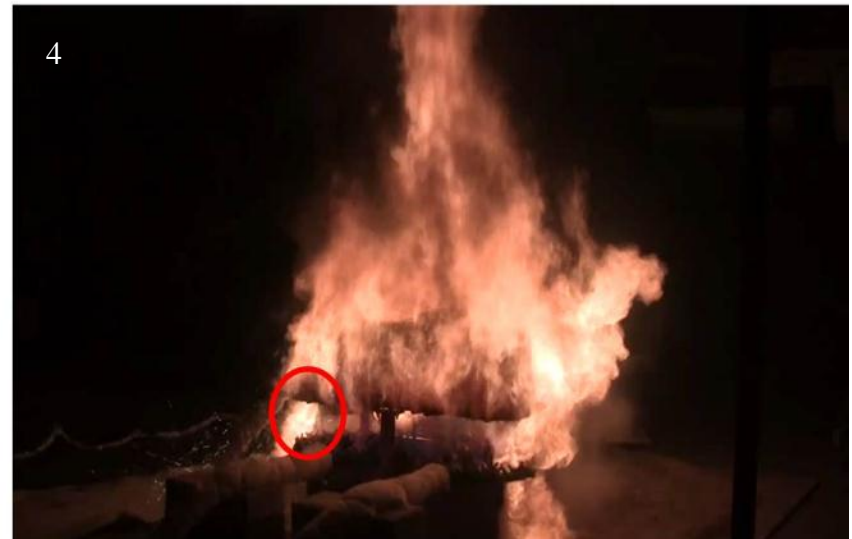
Figure 51 14:50 minutes: A large stream of sparks shoot out from the bottom of the NW end of the battery from its interior

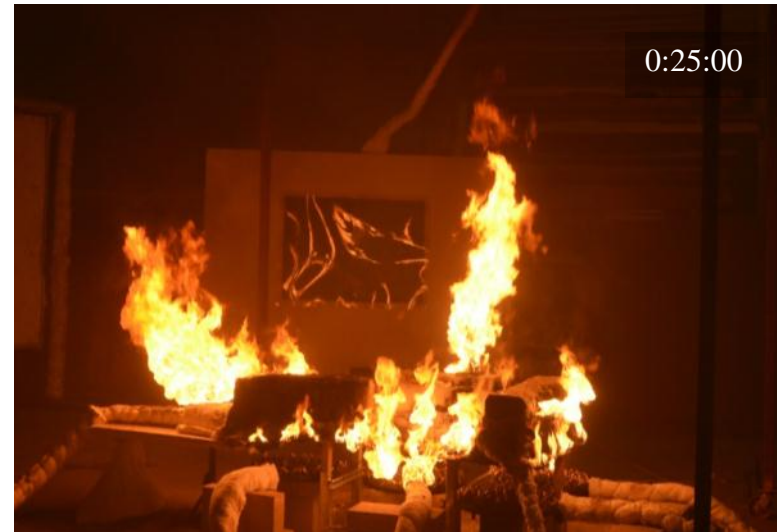
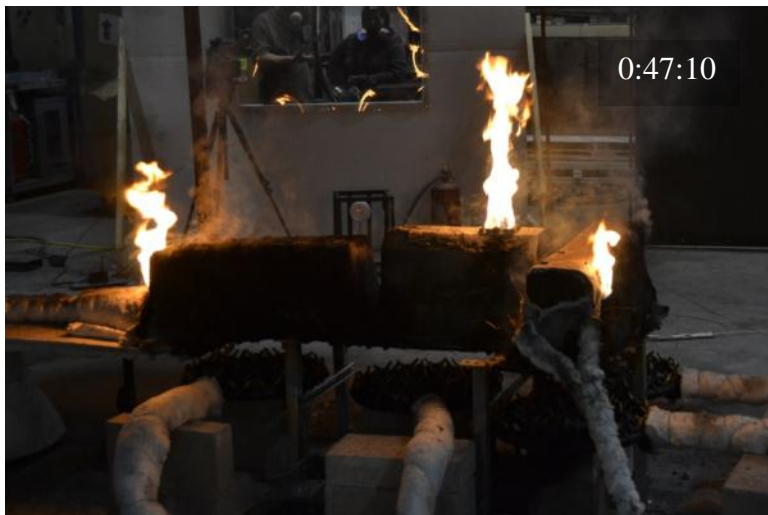
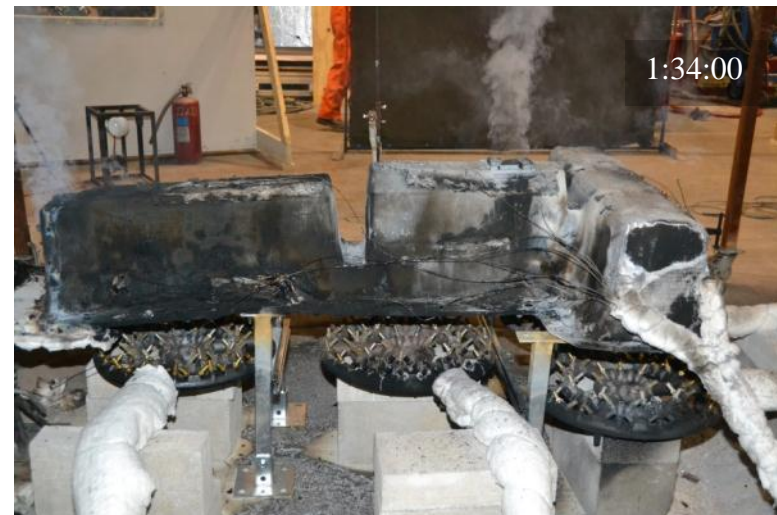
Figure 52 20:40 minutes (top left), 25:00 minutes (top right), 47:10 minutes (bottom left), 01:34:00 minutes (bottom right)

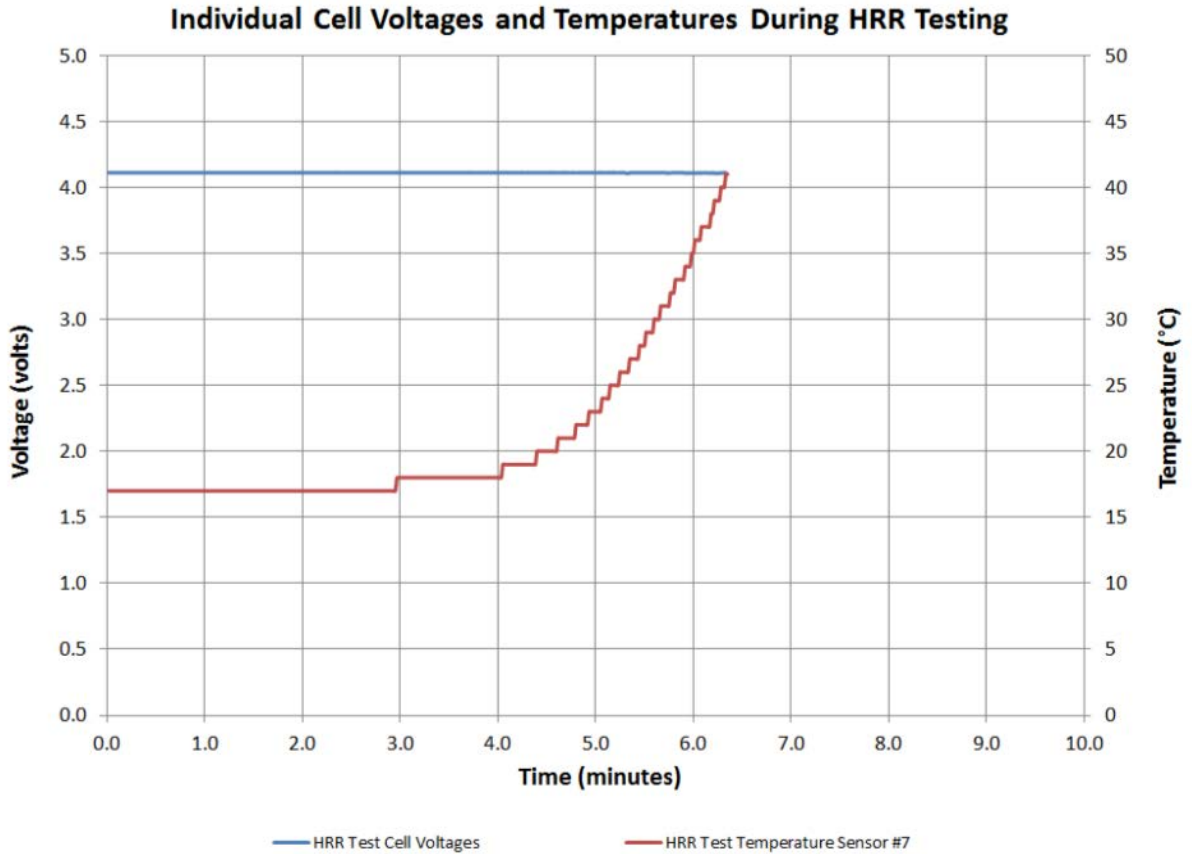
Figure 54 Internal cell voltages and temperatures (Sensor #7) during HRR Testing

Temperature Sensor #7 was found in the eastern portion of the long span of the battery, as shown in Figure 55. The closest internal thermocouple installed by Exponent (TC13) through the south vent spiked from approximately 200 °F at time 0:02:45 to over 1500 °F by 0:04:21, when communication with the battery ceased. A post-test forensic investigation into the CAN bus and DAQ system communication cables and connections points revealed the failure mode was internal to the battery, possibly a short in the CAN bus power supply. The battery CAN bus operates on an externally provided 12V power supply. The power is provided through pins in the same connector that carries the CAN bus signal pins. During the burn tests, this power was provided by a GPC-3030D power supply. When CAN bus communication failed, the output power of the supply dropped from 12V to approximately 8V and the power supply switched from constant-voltage to constant-current mode, indicating that the power supply terminals had been short-circuited internally. The CAN bus cables spanning from the DAQ to the CAN bus connection area were retrieved after the tests and the continuity of the pins carrying the input

voltage was checked. The cables were not short-circuited, further indicating that the communication problem was internal to the battery. The likely failure mode was an internal wire transmitting power to the CAN bus developed a short circuit, terminating the ability of the battery to communicate via the CAN bus.

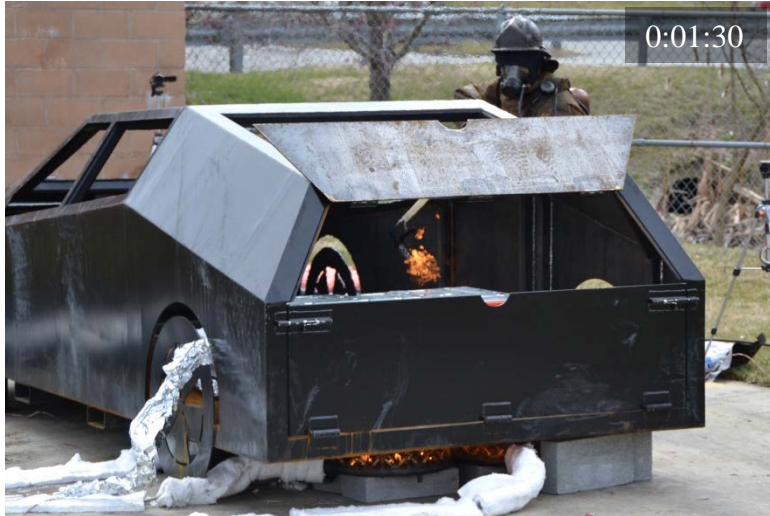
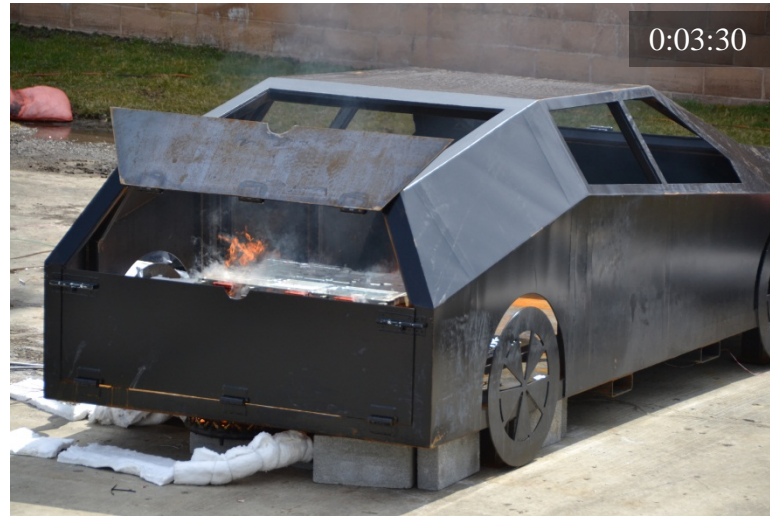
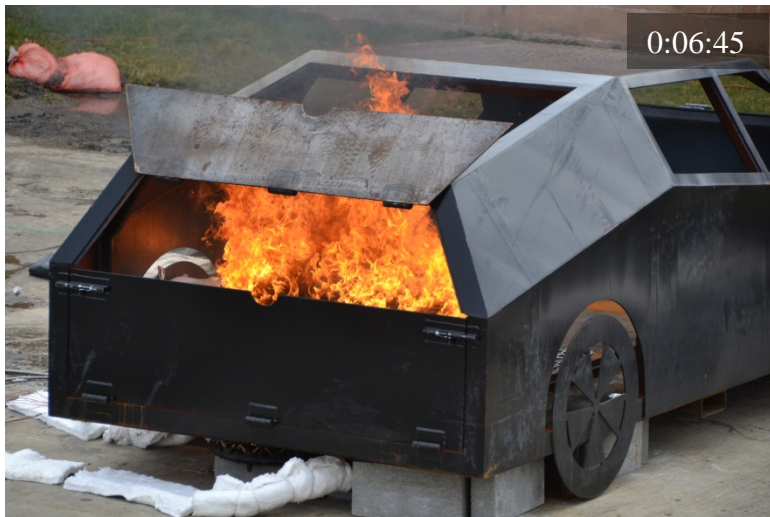
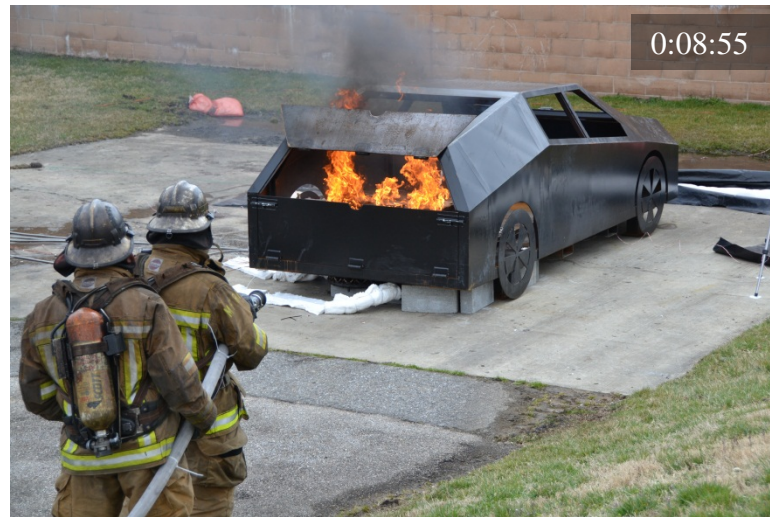
Figure 57 Test A1: ignition (top left); off gassing (top right); fully involved (bottom left); burners off (bottom right)

Table 10 summarizes the key events observed by Exponent staff during the suppression testing. Images at significant test times are provided in Figure 57 and Figure 58. In general, the test demonstrated that an external heat source, such as the propane burners, could induce Battery A into thermal runaway while it was positioned inside the VFT and result in visible release and ignition of electrolyte material. Loud popping sounds from the interior of the battery were heard and visible sparks were observed on many occasions throughout the test. White smoke

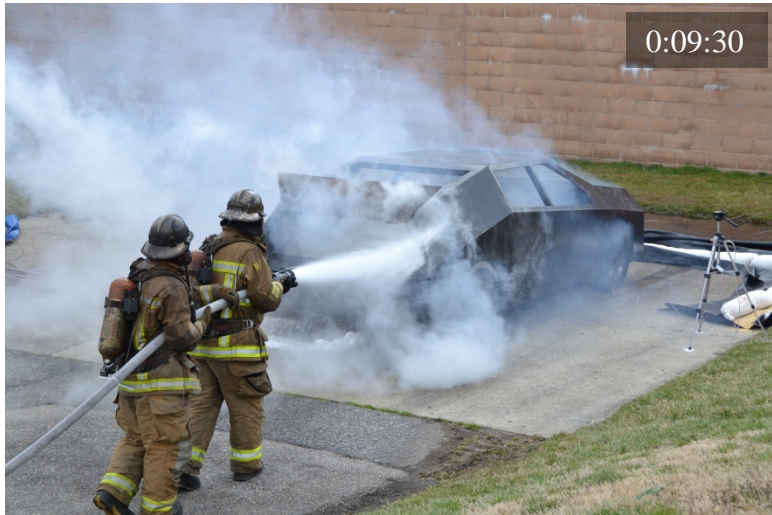
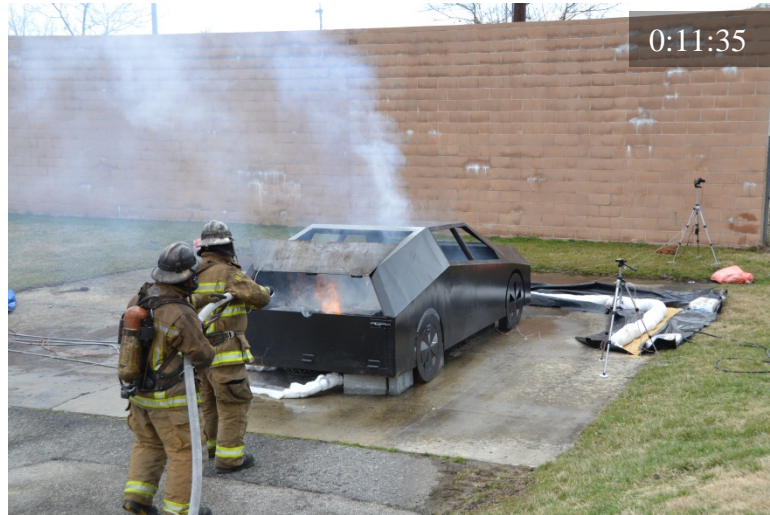
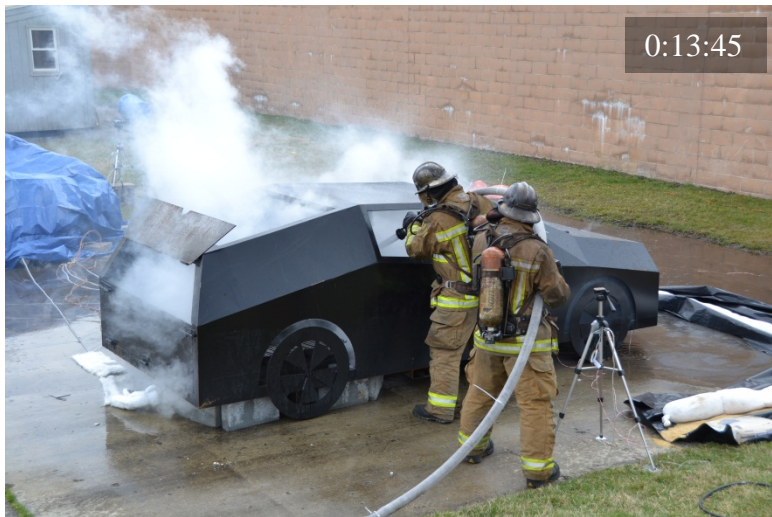
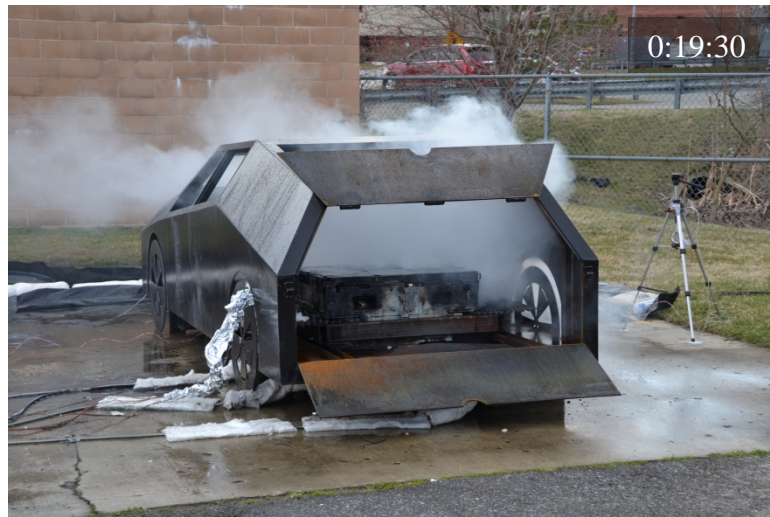
Figure 58 Test A1: Suppression starts (top left); reignition and suppression (top right, bottom left); post suppression (bottom right)

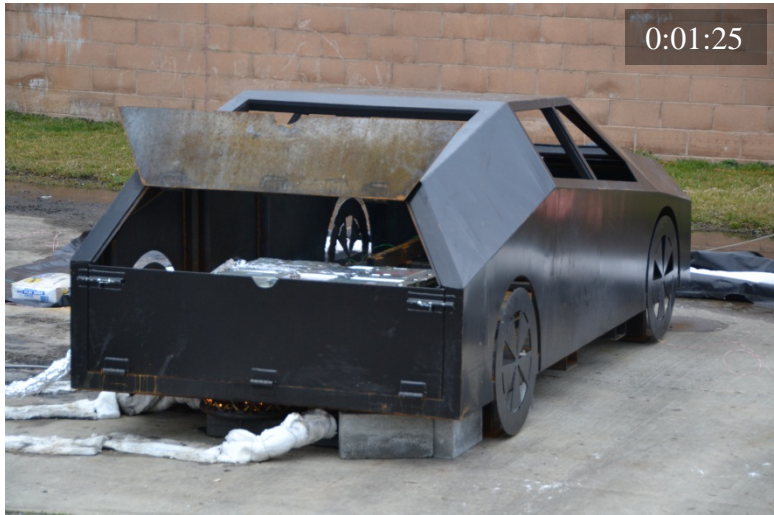
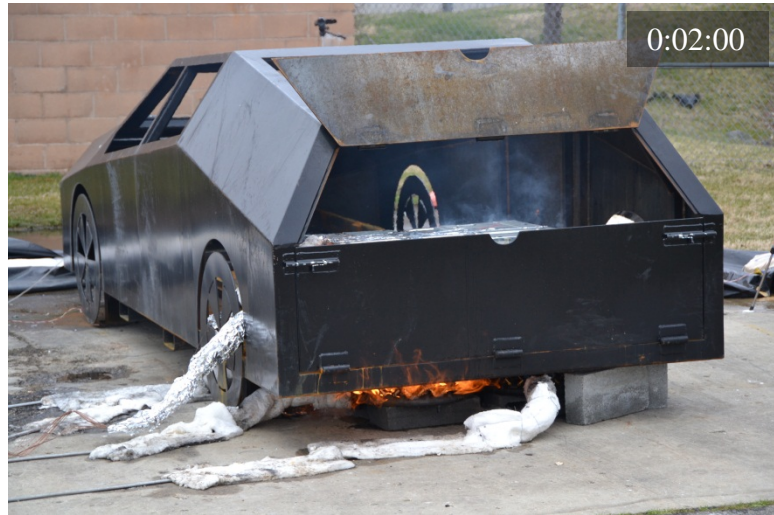
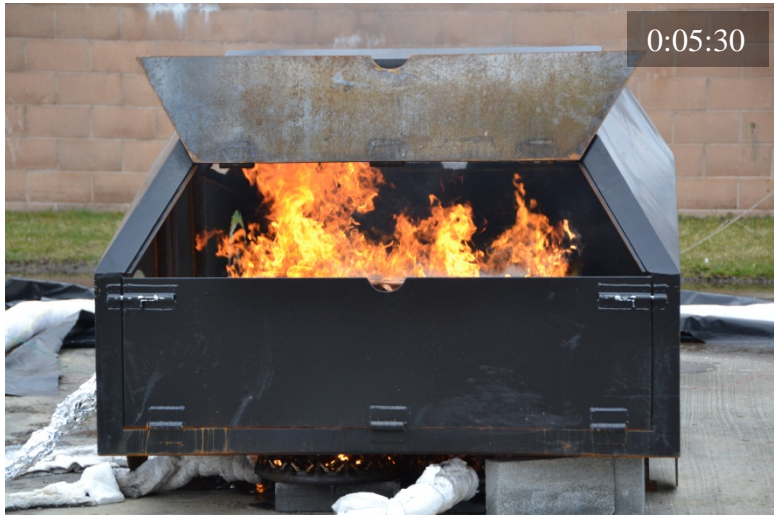
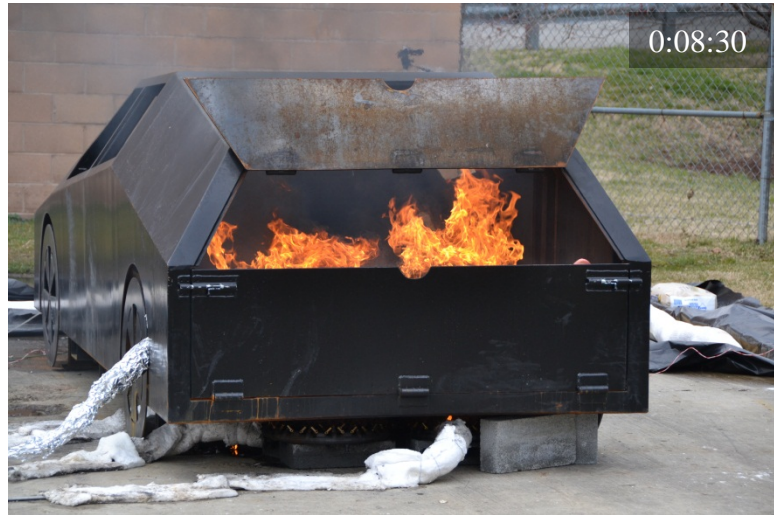
Figure 62 Test A2: ignition (top left); off gassing (top right); fully involved (bottom left); burners off (bottom right)

Table 16 summarizes the key events observed by Exponent staff during Test A2. Images at significant test times are provided in Figure 62 and Figure 63. In general, the test performed similarly to Test A1, where the battery was induced into thermal runaway by the burners and did not noticeably decrease in fire size once the burners were turned OFF. Visible release and ignition of electrolyte material was observed and loud popping from the interior of the battery was heard coinciding with the observation of visible arcing/sparks on many occasions. The white smoke and white off gassing observed on several occasions were consistent with the release of electrolyte material. Of interest during Test A2, was the ability to predict the release

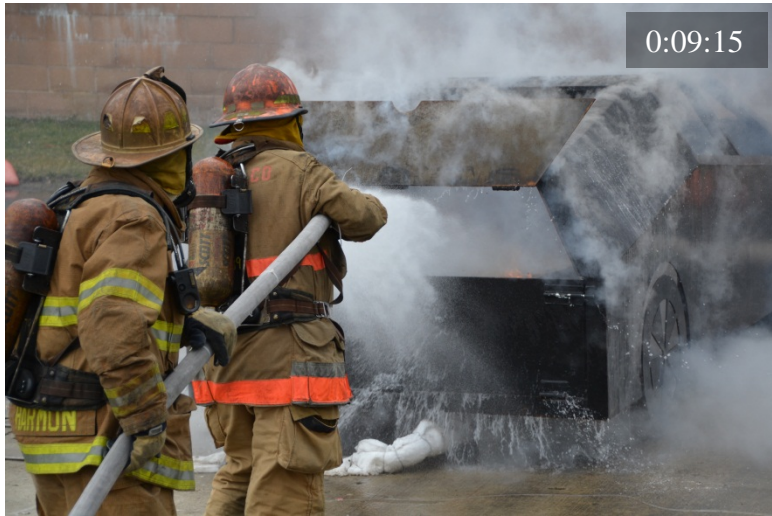
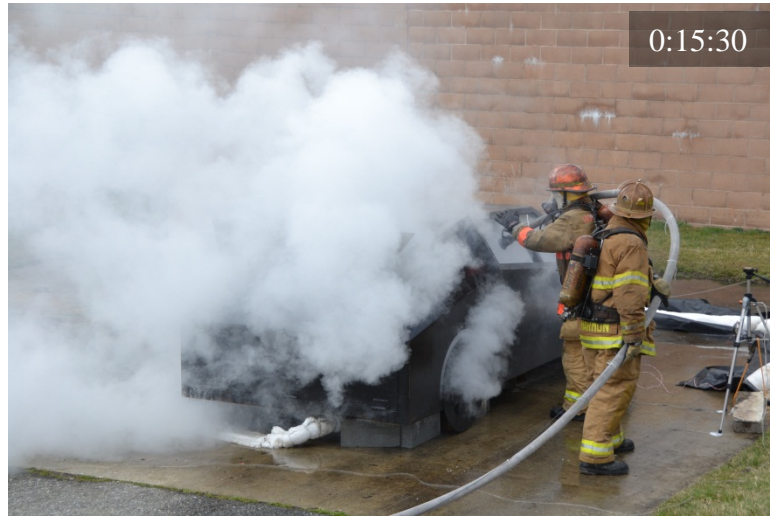
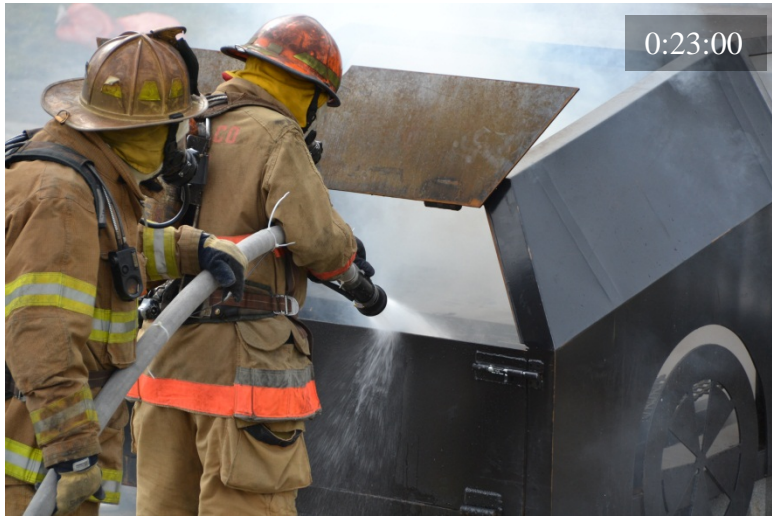
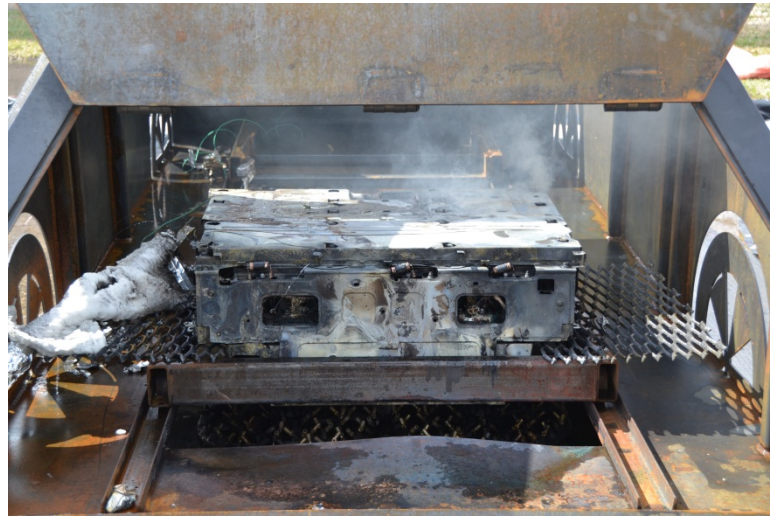
Figure 63 Test A2: suppression starts (top left); reignition and suppression (top right, bottom left); post-suppression (bottom right)

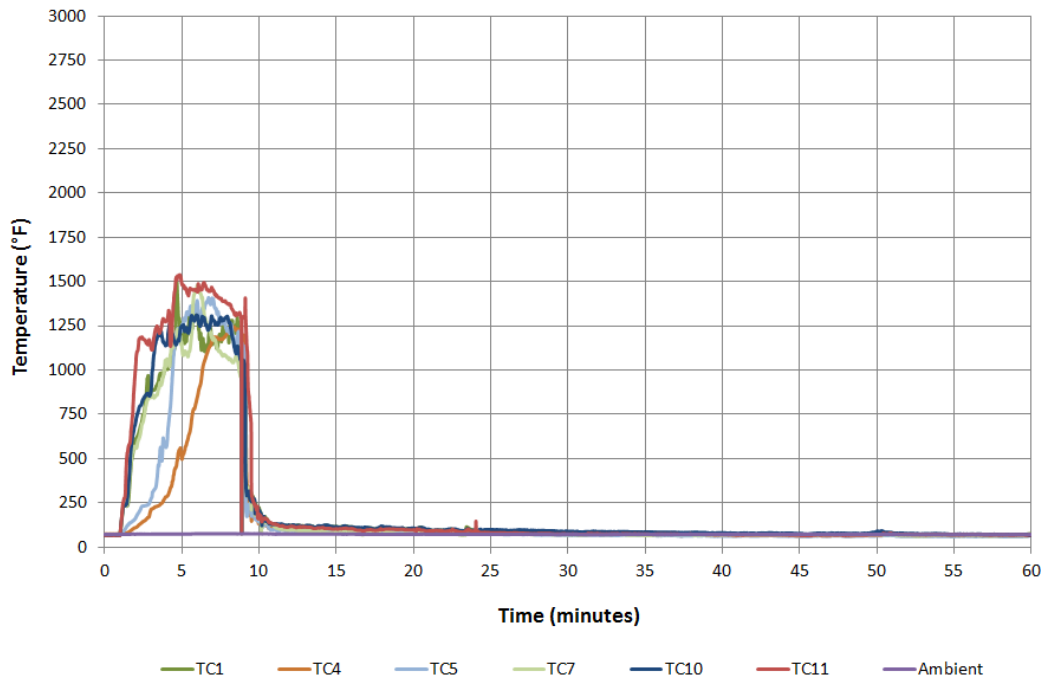
Figure 69 Test A3 TC plot

Temperature and heat flux measurements were collected by Exponent during Test A3 once every second. The maximum temperatures and heat fluxes measured during the test and their corresponding times have been summarized in Table 24 and Table 25 plotted in Figure 69 and Figure 70.<sup>62</sup> The majority of the maximum temperatures measured during the test occurred prior to the burners being turned OFF. TC4 experienced a maximum temperature after the burners were turned OFF, prior to the start of suppression.

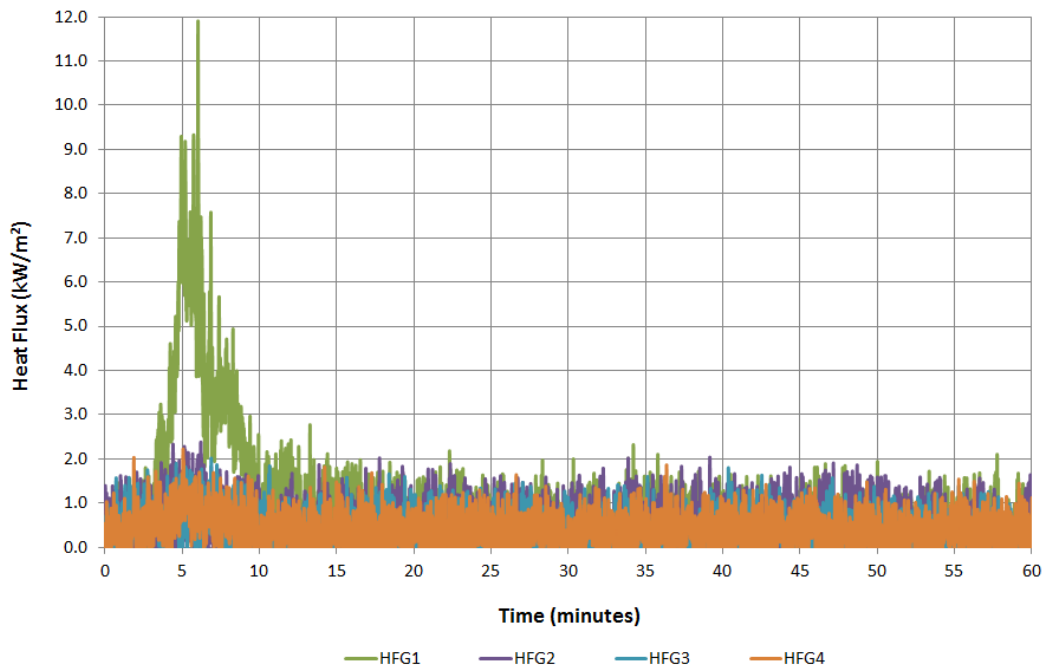
Figure 70 Test A3 HFG plot

The heat flux measurements followed the same trend as the TC data, as all of the maximum values were found before the burners were turned OFF. The maximum heat flux from the VFT was 11.9 kW/m<sup>2</sup> at a standoff distance of 5 feet and at further distances, 15, 20, and 25 feet, the maximum heat fluxes were between 1.6 and 2.2 kW/m<sup>2</sup>.

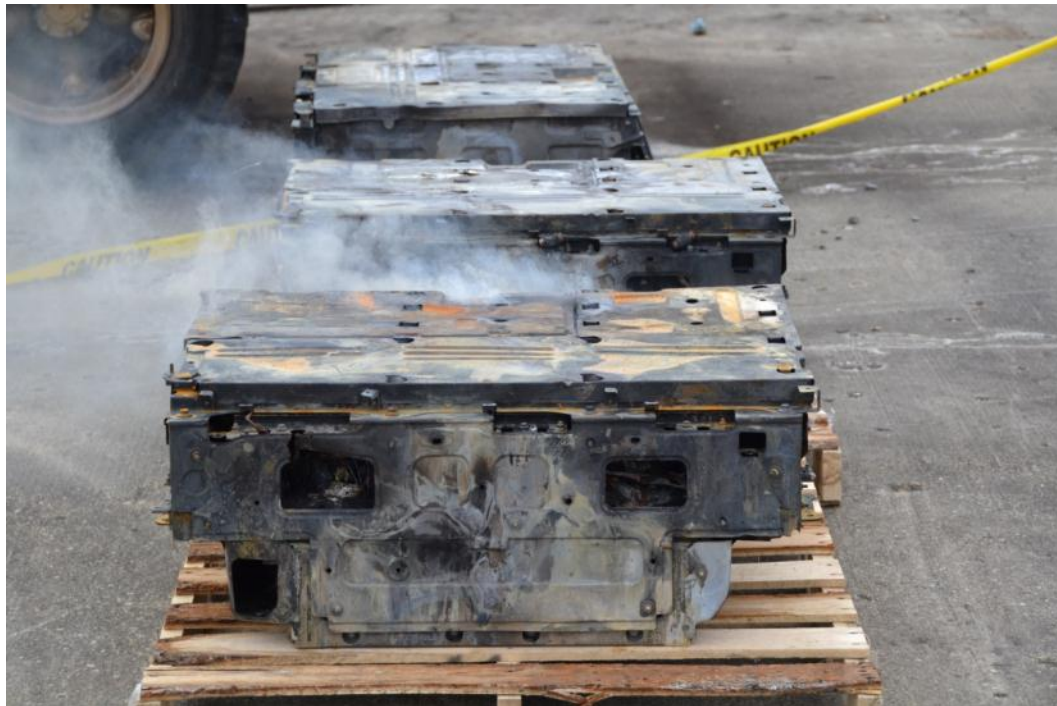
At approximately 1:02 p.m., 22 hours since the conclusion of the test and 4 hours since its removal from the VFT, Battery A3 began to lightly off gas, as shown in Figure 72. Shortly thereafter at 1:07 p.m. (5 minutes after off gassing was first observed) flames were visible on the interior of the battery, as shown in Figure 73 and pops were heard. MFRI staff quickly connected a hose line and extinguished the flames and cooled the exterior of the battery. It was estimated that an additional 2 minutes of water was applied to the battery at a flow rate of 125 gpm. By 1:40 p.m. (38 minutes after off gassing was first observed), the battery had stopped

Figure 72 Off gassing of Battery A3 approximately 22 hours after the conclusion of the test

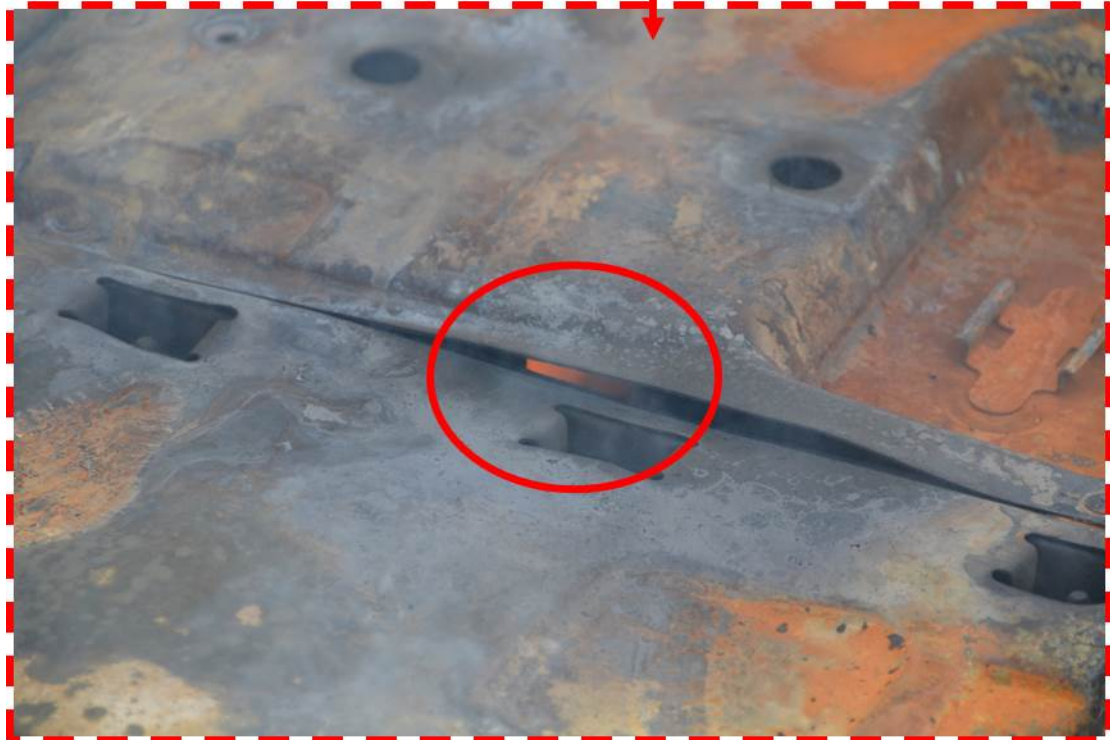
Figure 73 Reignition of Battery A3 approximately 22 hours after the conclusion of the test (flame circled red)
